HOME INSPECTION REPORT

Date of Inspection: 1/4/2019

How's My House Home Inspections 516-732-7595

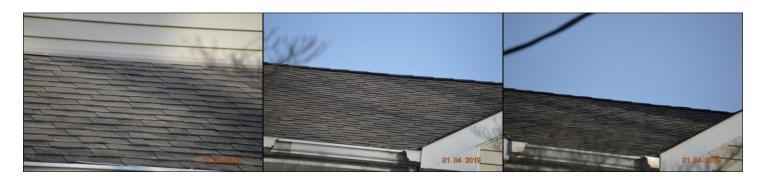
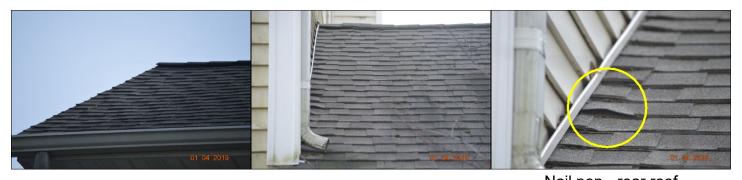
- Roof shows normal wear for its age and type. No damaged, deteriorated, or missing roofing materials were observed; it appears to be in serviceable condition.
- Moss/fungi growth observed.
- Nail pops

Moss growth - rear roof
